AC 2007-625: RE-WIRING A POWER/MOTORS LABORATORY FOR IMPROVED STUDENT SAFETY

Re-wiring a Power/Motors Laboratory for Improved Student Safety

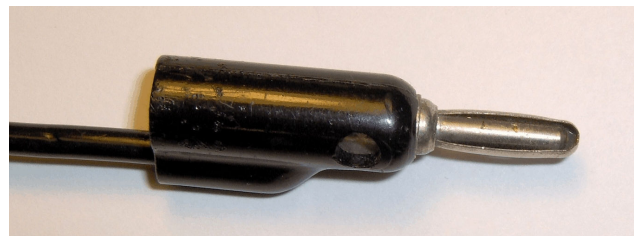
Banana plugs are held in place by the friction created by springs on the side of the metal connector. Figure 4 shows a close-up of a banana plug in which one of the springs has broken off, due to metal fatigue resulting from numerous insertion/removal cycles. When that occurs,

the holding strength of the plug is reduced and it is susceptible to being accidentally knocked out of the socket. To avoid this, the students are instructed to always check the leads at the start of lab and to verify they are in good repair. However most, if not all, of the arc events that have occurred in the lab were likely due to students not turning off the power prior to disconnecting all or part of the circuit. Author DeWitt on one occasion observed a student who removed a hot lead and then, realizing it was hot, stood there swinging it back and forth, unsure what to do. Before the student could decide what to do or the instructor could intervene, the hot lead made contact with the bench. Fortunately, no student has ever been injured, as the circuit breakers have always operated in sufficient time to prevent anything more than superficial scarring of the benches and a damaged lead. (Note: students are required to wear approved eye protection in lab.)

Figure 4: Damaged banana plug

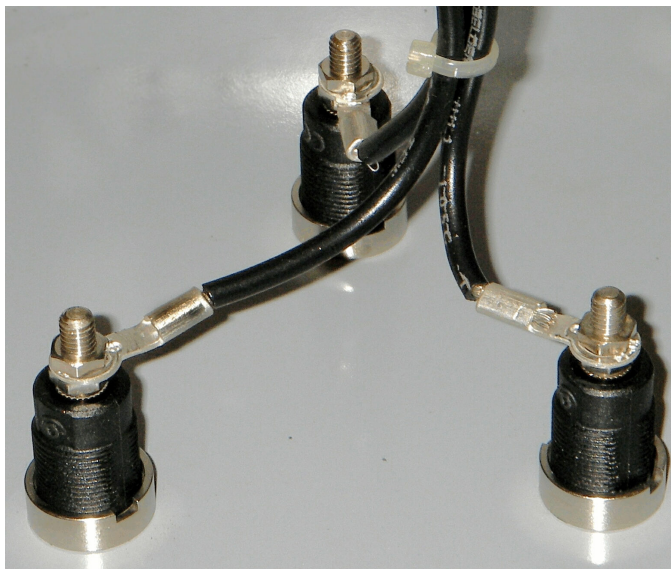
Figure 9 shows the backside of three safety sockets. Connections are made to them by screwing nuts onto post connectors. It was found, however, that tightening down the nuts pulled the post connector loose from plastic portion of the socket. It quickly became evident that the brand of connectors we had purchased would not be feasible and an alternative would have to be found.

Fortunately, a supplier for the European market was found. Samples were ordered from them and found to yield acceptable results, as shown in Figure 9.

Figure 9: Back connections to safety sockets

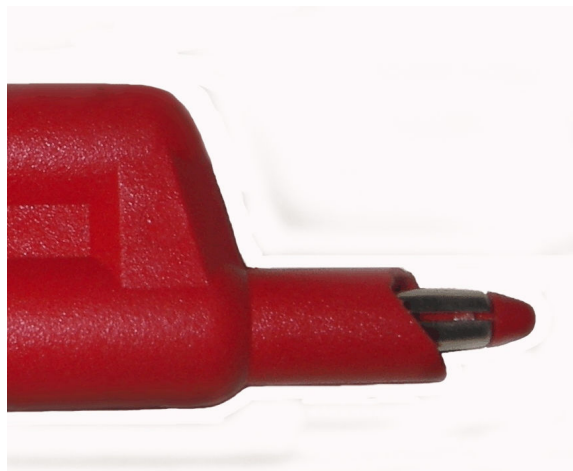
Unfortunately, the safety leads are not indestructible. Figure 10 shows a lead that was found to be broken, most likely by someone stepping on it. Thus, it is still necessary to instruct the students to check all of their leads before using them (it is also necessary to remind students not to leave leads lying on the floor).

Figure 10: Broken safety lead.
