Teaching Constructability Using Third-World Constraints

By David W. Dinehart and Shawn P. Gross

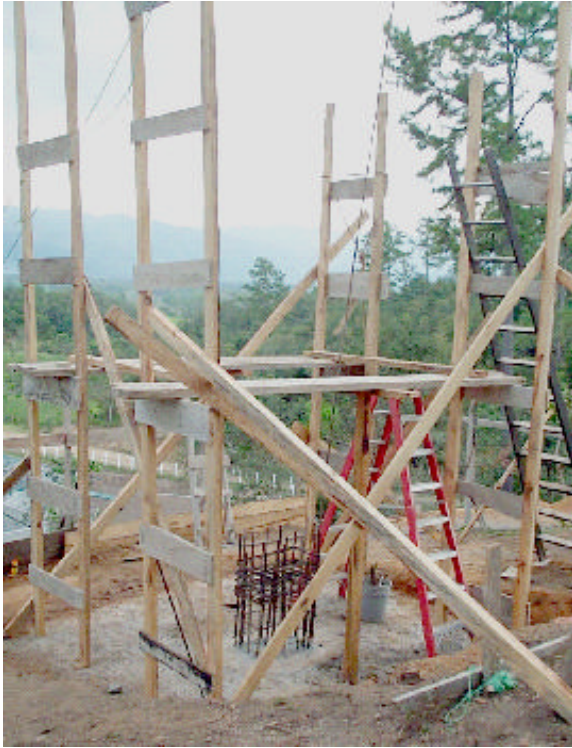
Figure 2: Scaffolding status at the end of day one (left); column rebar placement (right).

Day One: A short safety meeting was held to discuss some hazards of the site typical of US jobsites, and some that were unique to a third world country, such as, tarantulas, scorpions, and poisonous snakes. The group was subdivided into teams that rotated between hauling concrete materials up the hill to the site, column rebar preparation (cleaning, cutting, bending), fabricating the formwork for the second level (8-16 ft), and construction of the first level of scaffolding. Figure 2 (left) shows the status of the scaffolding at the end of day one.

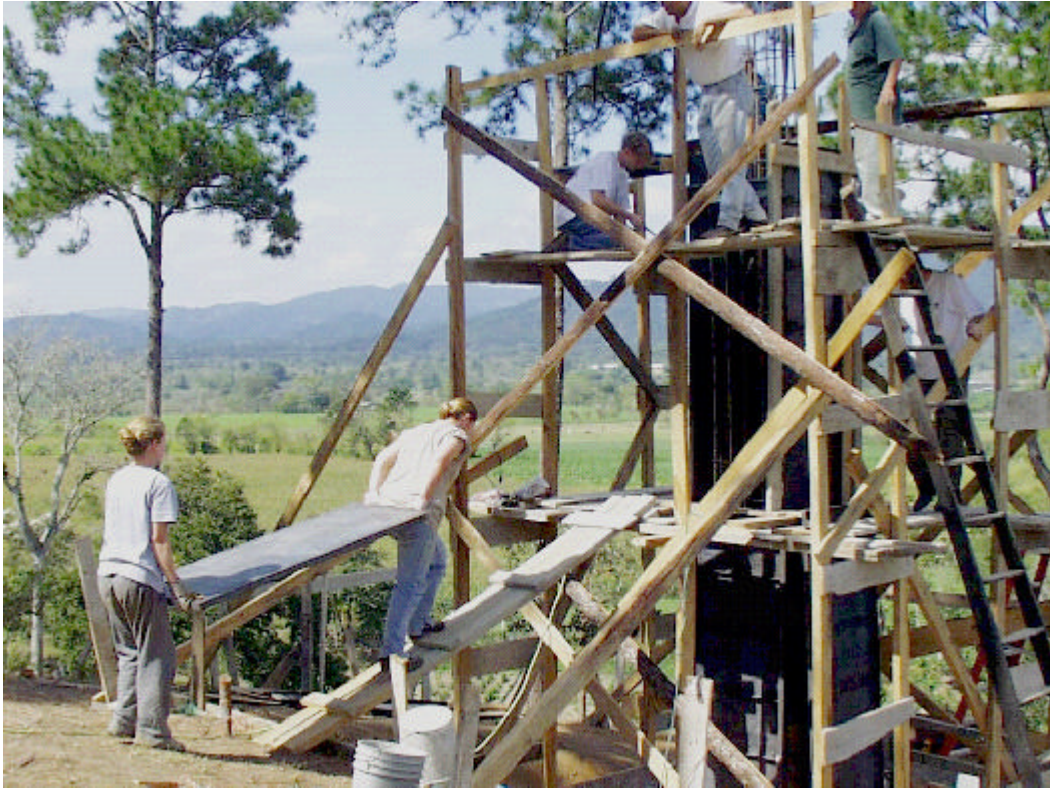
Figure 4: The second level of scaffolding is completed with a ramp to the first level.

Day Three: The rebar for the cross beam was cleaned, cut, and bent. Column ties were secured to the column from 8 – 16 ft, while the second level of scaffolding and the second level of formwork placement were completed. Figure 4 shows the ramp added to the scaffolding to allow for easier access to the first level platform. Work on the formwork for the beam and the top section of the cross continued.

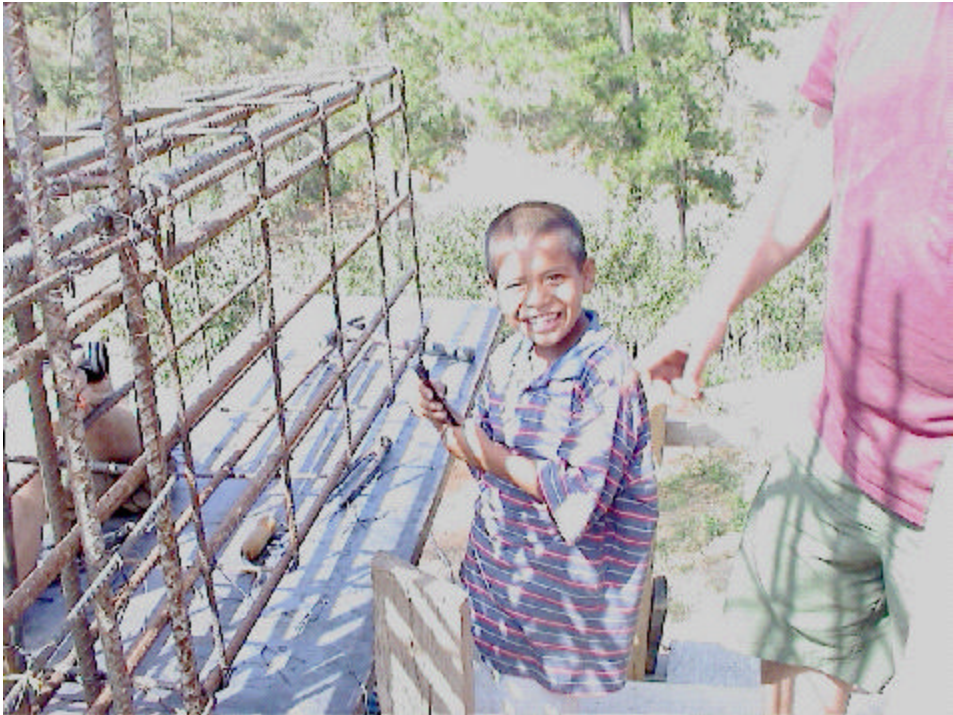
Figure 5: A “little helper” expedites the rebar placement of the cross-beam.

Day Four: There were still more trips of cement and five-gallon buckets of aggregate to the top of the hill. The rebar and stirrups for the beam were installed (Figure 5) and the formwork placed. One team finished fabricating the final formwork for top portion of the column. The final progress is shown in Figure 6 (left).

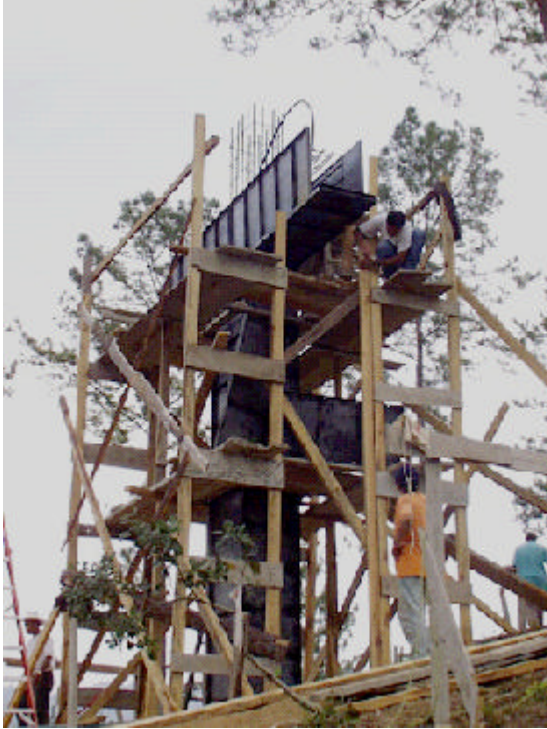
Figure 6: End of day four (left) and mixing of concrete (right).

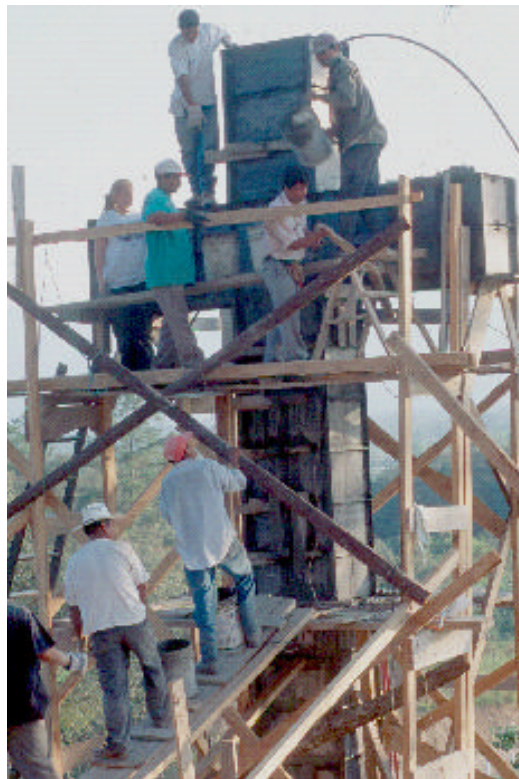
Figure 7: Placement of concrete in 5 gallon bucket increments.

Work for the concrete pour started with two crews of five hand mixing batches of concrete. Figure 6 (right) shows one of the crews mixing concrete. Concrete was placed in five gallon buckets and an assembly line of workers passed the buckets to the cross. The back panel (panel immediately in front of the scaffolding ramp) was left off and concrete for the first level of the column was poured through the opening. Concrete was vibrated in one foot intervals until the first level of formwork was full. The back panel of the second level of formwork was then bolted into place, and the pour commence. Ten cylinders were taken throughout the pour; four each from the first and second levels of the column, and two from the beam. The total pour took approximately four hours. Figure 7 shows the final moments of the pour and the assembly line of concrete buckets. All exposed surfaces were finished and covered with wet cardboard. The cross with formwork removed and the painted final product are shown in Figure 8, top and bottom respectively.

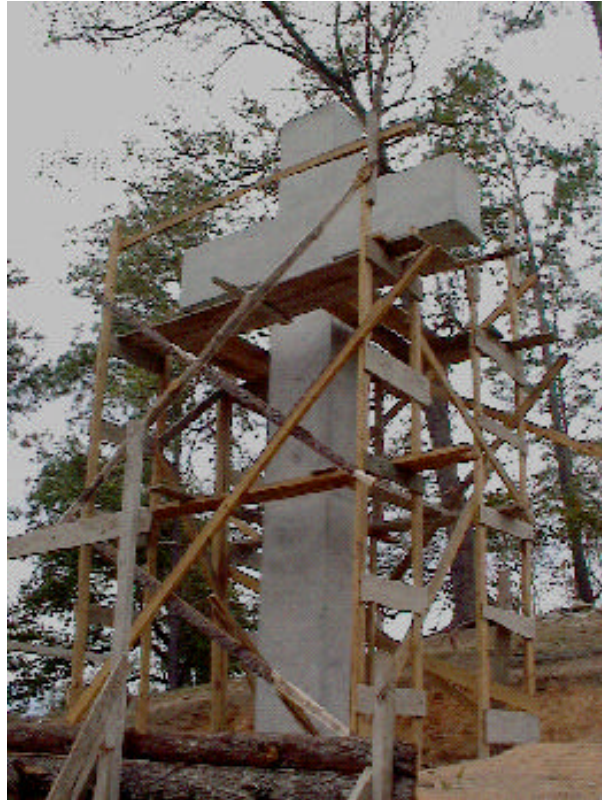
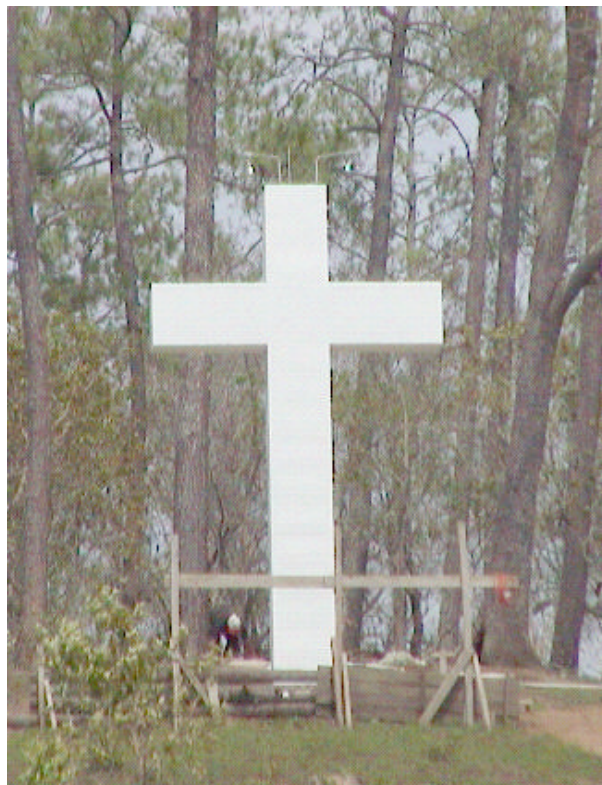
Figure 8: The cross after the formwork was stripped (top) and the final product (bottom).
