# **Practical Design Considerations for Large Marine Structures in South Carolina**

**Robert E. Dullanty Sr., P.E.  
Principal Engineer  
Schneider & Associates, Inc.**

## **Abstract**

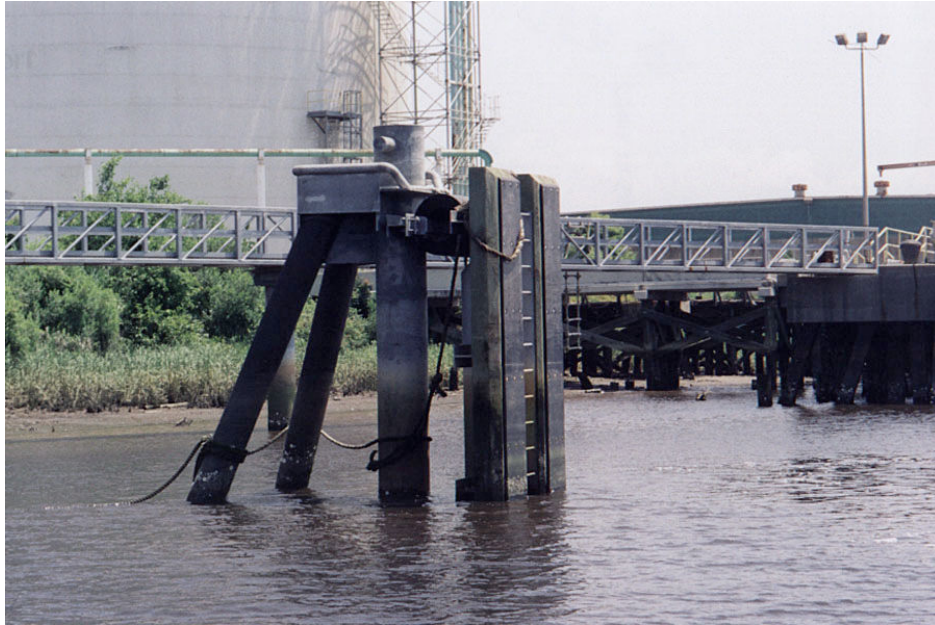
Breasting and Mooring Dolphin in Georgetown, South Carolina. This project required an energy evaluation of ship impact forces to determine the design forces, and the design of the structure to transfer 50-tons of horizontal force into soils consisting of limestone over silt.

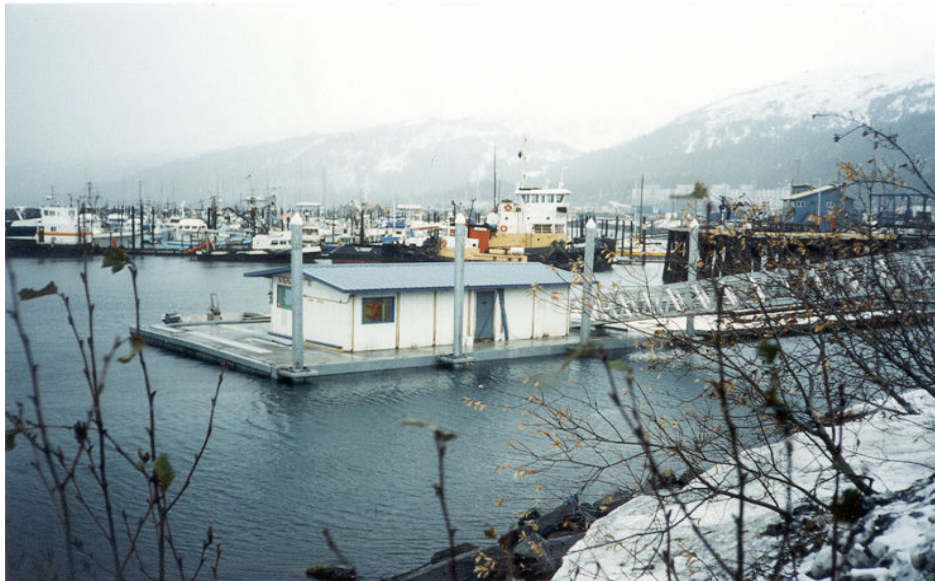
This 40-foot by 60-foot floating concrete fuel dock is located in Whittier, Alaska. The project involved wave forces, movement due to 30+ foot tide changes, buoyancy calculations, as well as concrete design, pile design, aluminum gangway design and the design of fuel lines, water lines, and power.

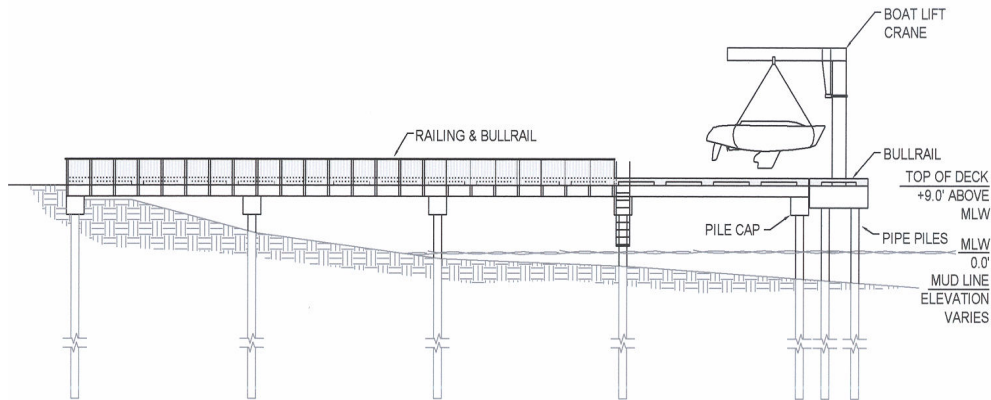
This fixed pier is located in Charleston, South Carolina. The design allowed launching of sailboats at low tide. This involved light vehicular loading, crane evaluation and loading, pile foundation design in Charleston’s “Cooper Marl”, and alignment with the currents, sedimentation concerns and prevailing winds.
